# Case Study

## Analysis of Two Stage Planetary Gearbox Vibration

KSC Consulting LLC  
Ken Singleton – Manager

### Abstract:

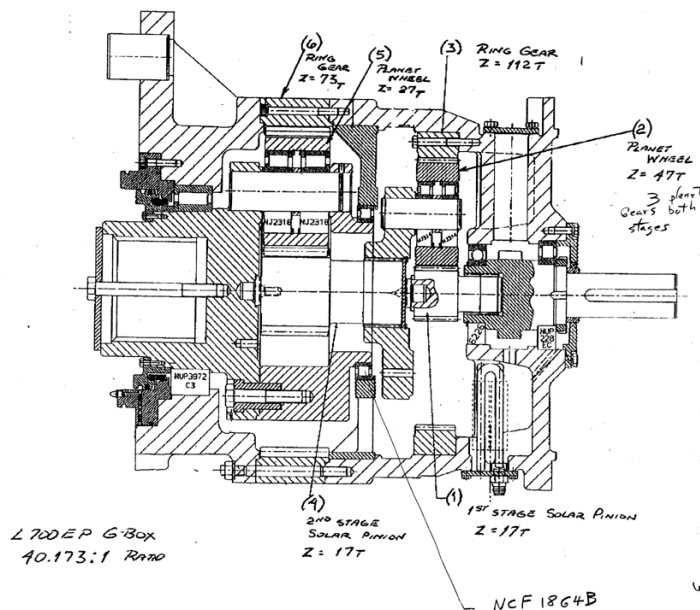
Gearboxes used in underground coal mining are of compact design. A typical two stage planetary gearbox, 800 HP, 40.173:1 Ratio with 1800 RPM input is shown in **Figure 1**. The unit was received by a repair facility for rebuild following failure from an overload incident. It was reported that the bearings were replaced and that one bearing had broken into many fragments. Following repairs a no load spin test of the gearbox was performed as a check for bearing faults, **Figure 2**. There was an audible impacting type noise from the input planetary section.

Figure 2. Cutaway View of 2-Stage Planetary Gearbox, 40.173:1 Reduction.

Before a determination of the source of the vibration could be made, an understanding of the gearbox design was required and calculation of the excitation frequencies. Based on the information provided by the drawing shown in **Figure 1**, several calculations were made to obtain the shaft speeds, bearing fault frequencies and gear meshing frequencies.

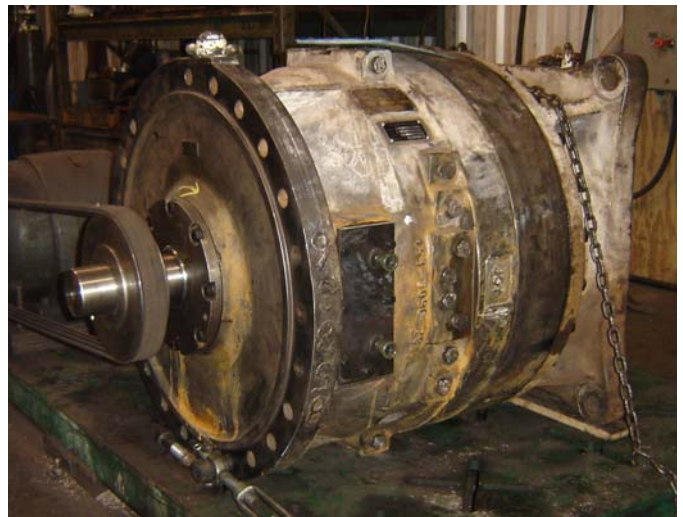
Figure 2. Gearbox On Test Stand For No Load Spin Test.

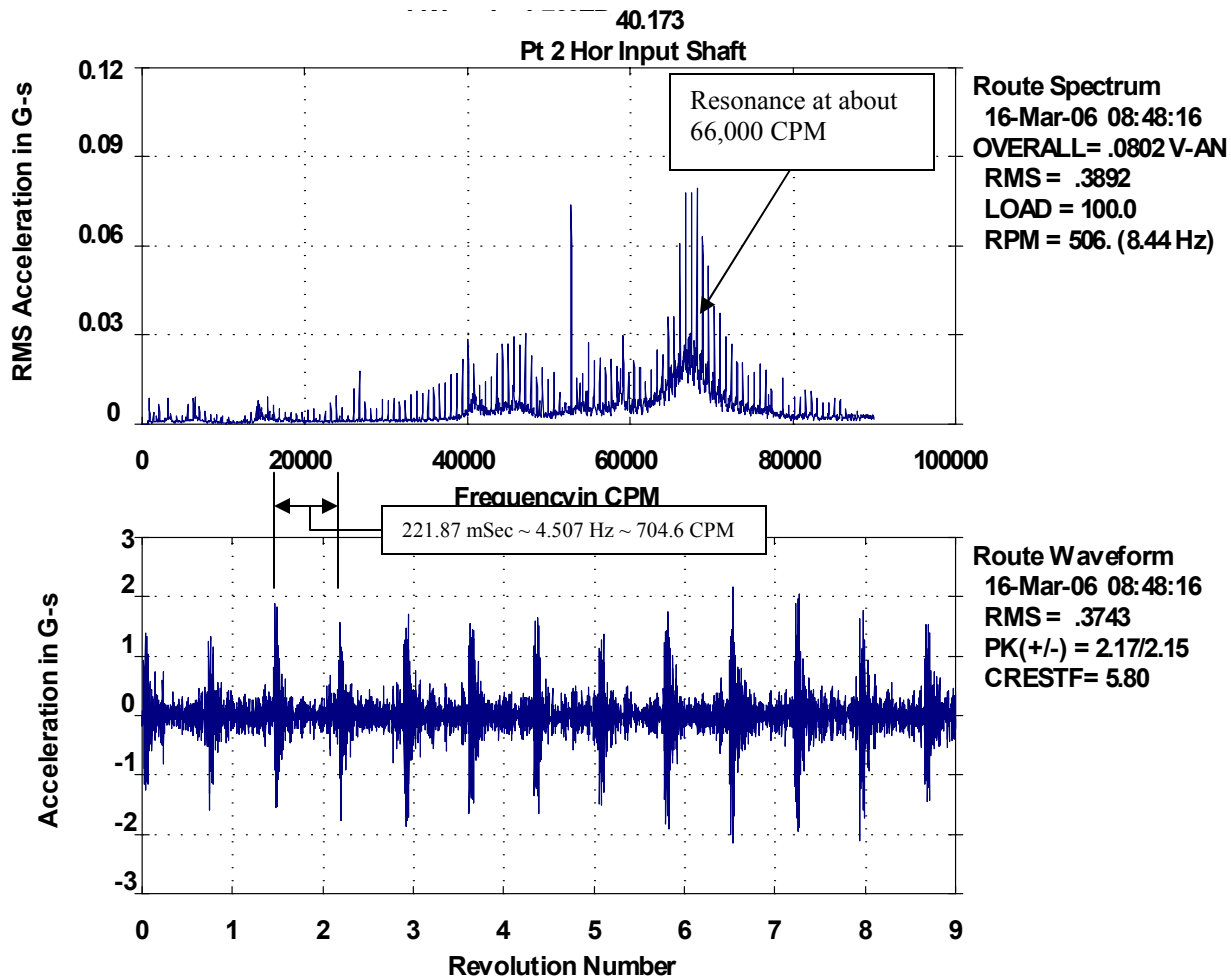
During the spin test, vibration data were measured using an accelerometer with rare earth magnetic mount. Initial inspection of the data indicated impacting and ringing of natural frequencies of the gearbox, **Figure 3**. The impacts measured a 221.87 mSec period or 4.507 Hz ~ 704.6 CPM. The FFT of the time domain data showed harmonics of 704.6 CPM and indication of excitation of several natural frequencies of the gearbox.

**Figure 3. Vibration Signal Measured at Gearbox Input Section Showed Impacts at 221.87 mSec Interval ~ 4.507 Hz ~ 704.6 CPM. The FFT (Top Plot) Indicated Excitation of Several Resonant Frequencies Including A Very Response One at About 66,000 CPM ~ 1,100 Hz.**

Referring to the data plots in **Figure 3**, it was readily determined using the vibration software cursors that the impulse frequency was 4.407 Hz ~ 704.6 CPM. A check of the frequencies in **Table 2** showed that this frequency does not match any of the bearing fault frequencies.

A check of the gearbox shaft speeds and gear meshing frequencies in **Table 1** also did not immediately identify a forcing frequency. The pulses in the time domain measured 85.42 mSec ~ 11.7 Hz ~ 702.4 CPM. Since the gearbox has three planets in each stage an impulse could occur at three times the 1<sup>st</sup> stage carrier frequency of 234.838 CPM if there were damage to the ring gear teeth. This frequency was calculated as follows:

$$3 \times 234.838 = 704.5 \text{ CPM} \sim 11.74 \text{ Hz.} \quad \frac{1}{11.74} = 0.08517 \text{ Sec} \sim 85.17 \text{ mSec}$$

The source of the pulses was related to rotation of the carrier and the three planets in the 1<sup>st</sup> stage also called the planet passing frequency.

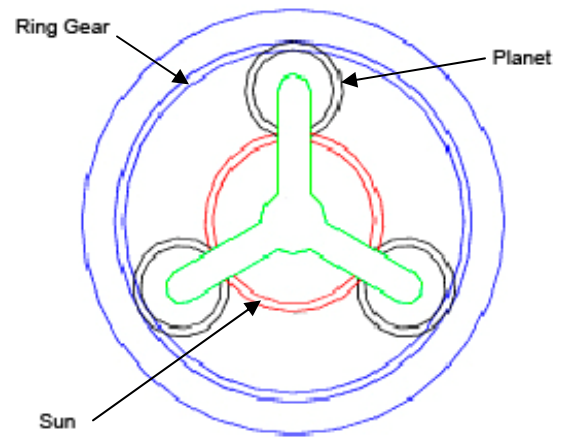
Epicyclic gear boxes derive their name from the epicycloidal curves that the planet gears produce during rotation. There are three general types of epicyclic arrangements, 1) planetary which consists of a stationary ring gear combined with a rotating sun gear and moving planet carrier, 2) star configuration which consists of a stationary planet carrier coupled with a rotating sun gear, and 3) solar gear that has a fixed sun gear combined with a moving ring gear and planet carrier. The planetary arrangement is most common and is shown by the schematic in **Figure 4**. The subject gearbox had the planetary arrangement for the 1<sup>st</sup> and 2<sup>nd</sup> stages. Input was from the sun with three planets supported by a carrier revolving about the sun pinion and the ring gear fixed.

**Figure 4. Gear Arrangement Of 1<sup>st</sup> Stage Planetary Input Section.**

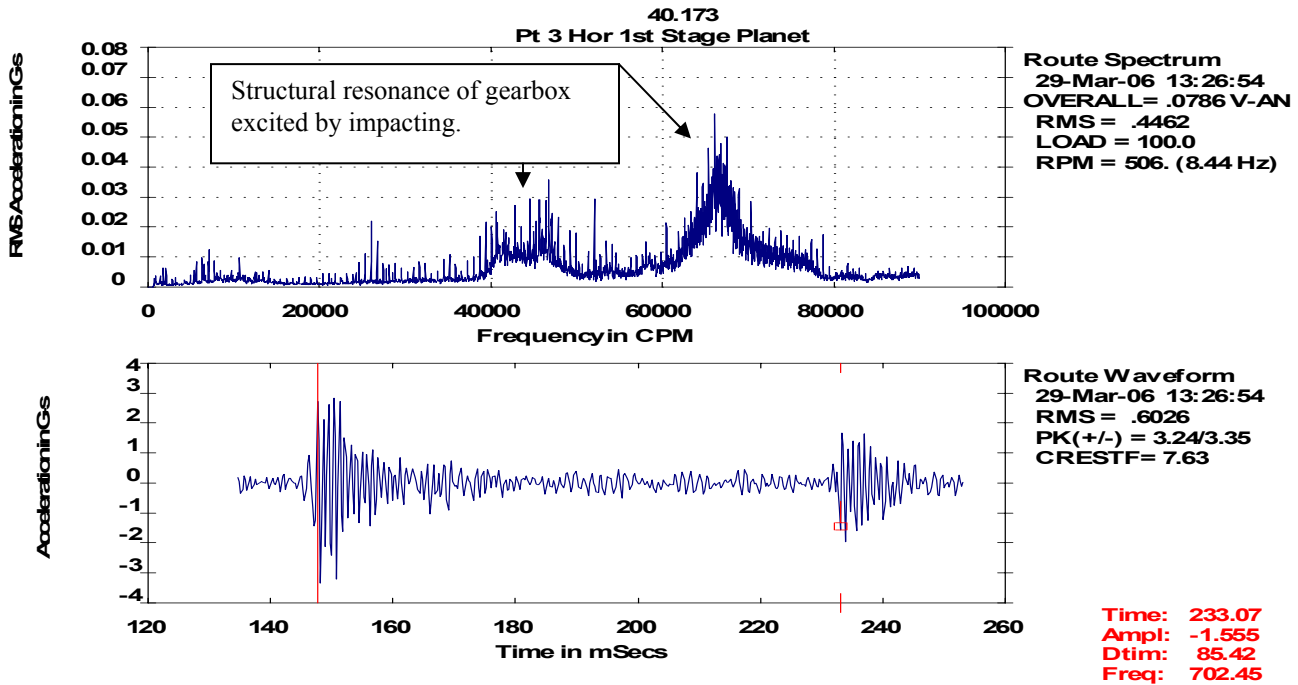
Expanding the time domain plot to show only two pulses, **Figure 5**, the pulses ring down which is typical response of structural resonance. The spectrum data also provided clear indication of resonance excitation.

**Figure 5. Time Data Expanded To Show Impacting and Ring Down.**

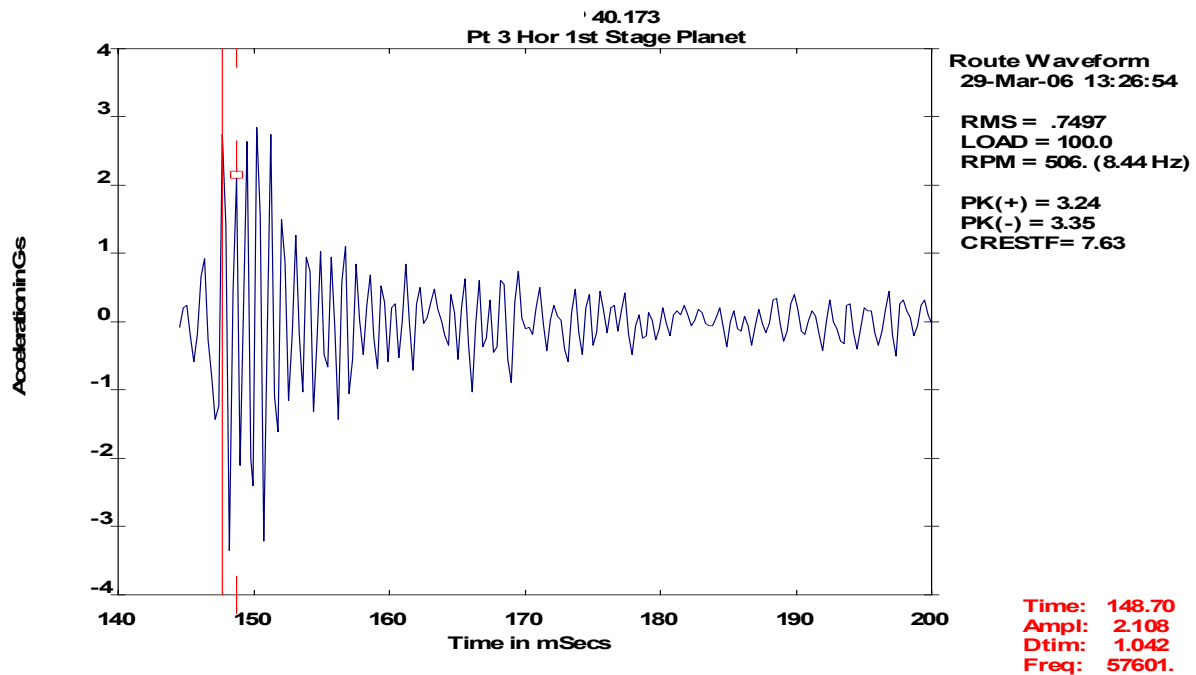
Plotting a single pulse in **Figure 6** showed more clearly the time between oscillations was about 1.042 mSec or 57,600 CPM. Note that spectrum analyzers don't make good oscilloscopes due to the rather coarse sampling at 2.56 times the maximum frequency to be displayed in the frequency spectrum.

**Figure 6. Expanded Plot of One of The Impact Events in The Time Domain Shows The Ring Down Frequency Is About 57,600 CPM.**

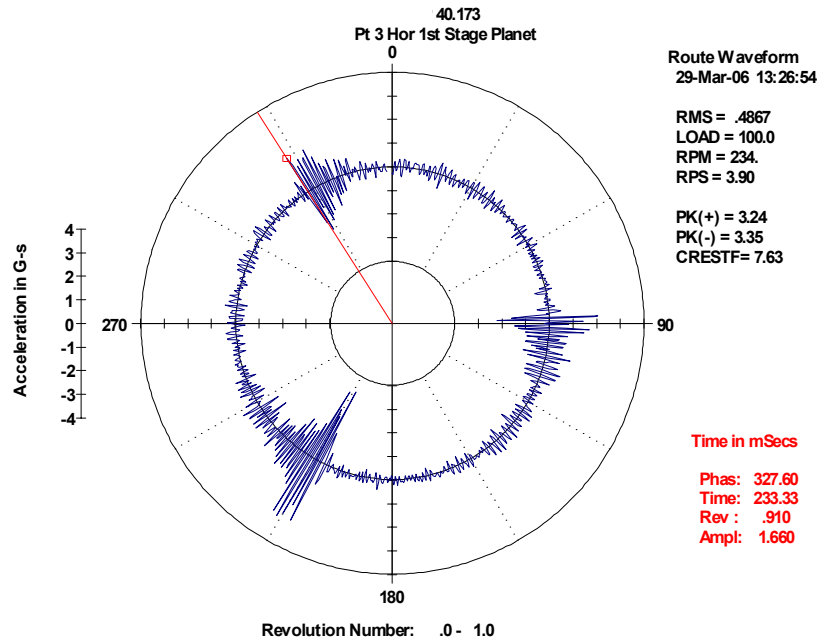
Plotting the time data in a circular plot, **Figure 7**, clearly shows three periodic impacts per revolution of the carrier. The impacts occurred as each planet rolled over a damaged ring gear tooth.

**Figure 7. Time Domain Data Plotted in Circular Format.**

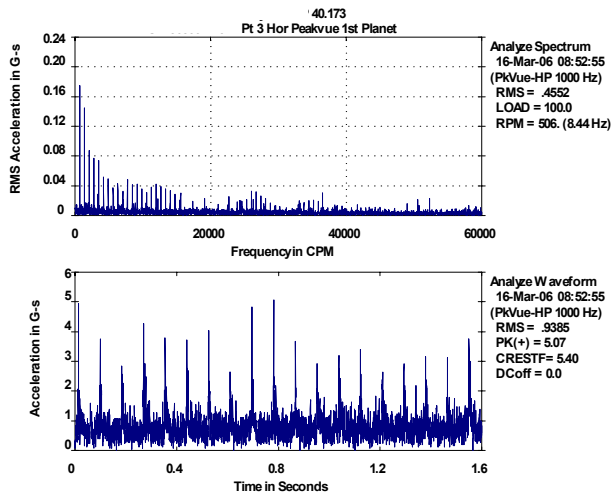
Peakvue spectrum and time domain data are plotted in **Figure 8** and shows impacting to about  $5g$ 's with the same frequency content as the normal vibration data. The auto correlation plot of Peakvue time data is plotted in **Figure 9** in a circular plot format.

**Figure 8. PeakVue Data Also Contained Impacting Data At the 3X the Carrier RPM.**

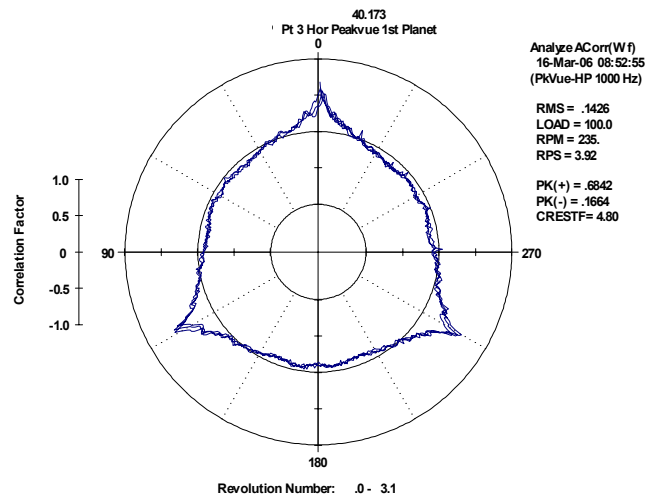
**Figure 9. Auto Correlation of Peakvue Time Data.**

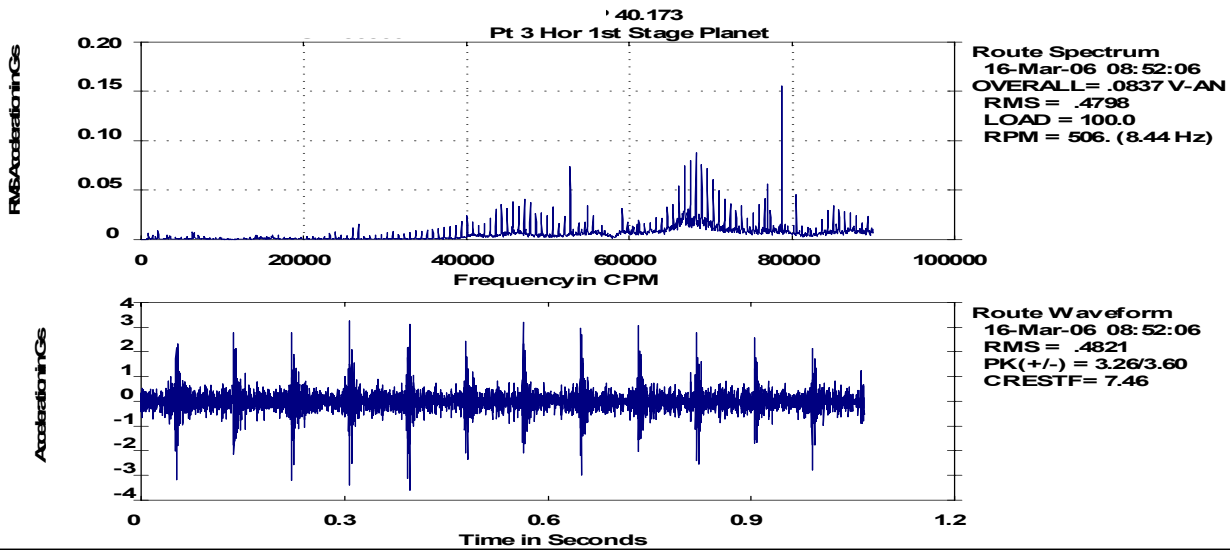
Before and after vibration data are plotted in **Figure 9 & 10**. The periodic impacting caused by the planet teeth rolling over the damaged ring gear tooth was reduced.

**Figure 9. Initial Spectrum And Time Domain Data With Brg Fragment Imbedded In The Ring Gear.**

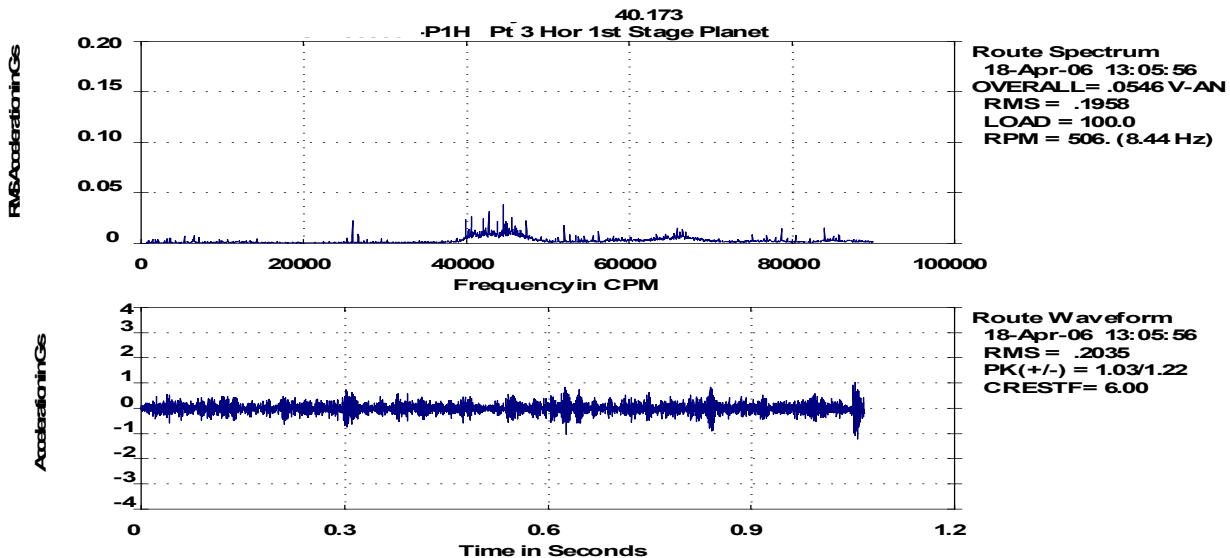
**Figure 10. Spectrum And Time Domain Data After Dressing Ring Gear Damaged Tooth.**

With the likely problem area in the gearbox identified, the gearbox was disassembled for inspection. A small fragment of the disintegrated bearing was found imbedded in the unloaded side of one tooth of the ring gear. The bearing fragment was removed, the damaged tooth dressed, the gearbox reassembled and spin tested again.

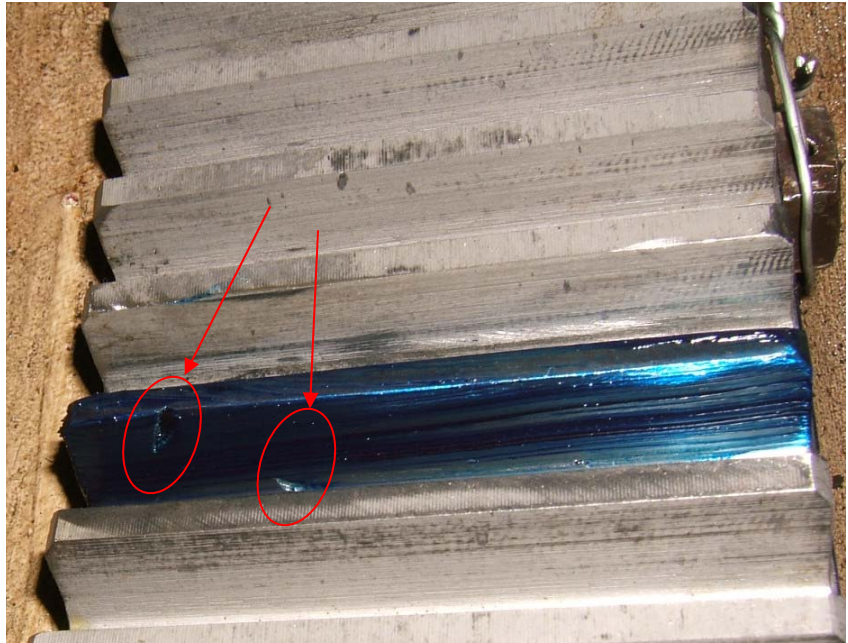
A photo of the damaged ring gear tooth is shown in **Figure 11** after dressing. Indentations can be seen where the tooth material was compressed by the bearing fragments.

**Figure 11. Ring Gear Tooth Afer Removing Brg Fragment & Dressing Raised Metal.**

This article describes the process that was used to analyze impacting type vibration of a two stage epicyclic planetary gearbox during a post-repair unloaded spin test. The forcing frequencies were calculated and identified the probably source of the vibration. Inspection of the ring gear identified fragments of a bearing race embedded in the unloaded side of a ring gear tooth.
