LOW SPEED BEARING ANALYSIS

Bruce Weathersby
KOSA
P.O. Box 4, Mail Drop 1.6
Highway 70 W
Salisbury, NC 281144

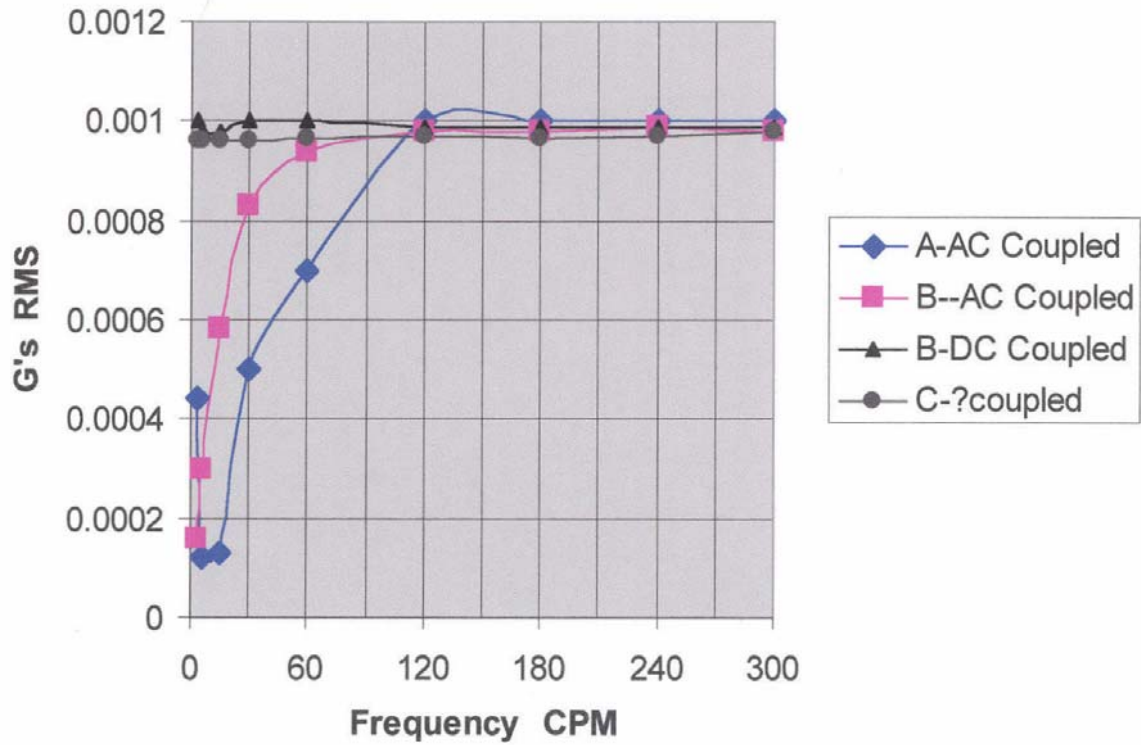
Figure 6. Results from Analyzer Brands A, B and C with .001 G RMS Input Signal at Different Frequencies

CPM	G's RMS Input	Brand A AC Coupled G RMS	Brand B AC Coupled G RMS	Brand B DC Coupled G RMS	Brand C G RMS
300	.001	.001	.00098	.00099	.00098
240	.001	.001	.00099	.00099	.00097
180	.001	.001	.00098	.00099	.00097
120	.001	.001	.00098	.00099	.00097
60	.001	.0007	.00094	.001	.00097
30	.001	.0005	.00083	.001	.00096
15	.001	.00013	.00058	.00098	.00096
6	.001	.00012	.00030	.00098	.00096
3	.001	.00044	.00016	.001	.00096

The results in Figures 6 and 7 are for a G's RMS reading from each analyzer. The results in Figures 8 and 9 are for the same .001G RMS level but are integrated into Velocity IPS Peak levels. Figures 10 and 11 show the results of the .001G RMS signal when double integrated to MILS Peak to Peak. Some analyzers have "corrected" values as well as different AC filters and DC coupled readings.

Clearly at the 5 hz (300 cpm) level most analyzers do a reasonable job of reporting correctly, even when integrated. The results change drastically the closer the signal of interest gets to 0 cpm. These results show conclusively that different analyzers report different results, many of them with large margins of error as the signals get closer to 0 cpm.

For reference, the analyzer described as B-DC coupled does the best job in Figures 6 through 11. It gives results that are close to perfect in all Figures.

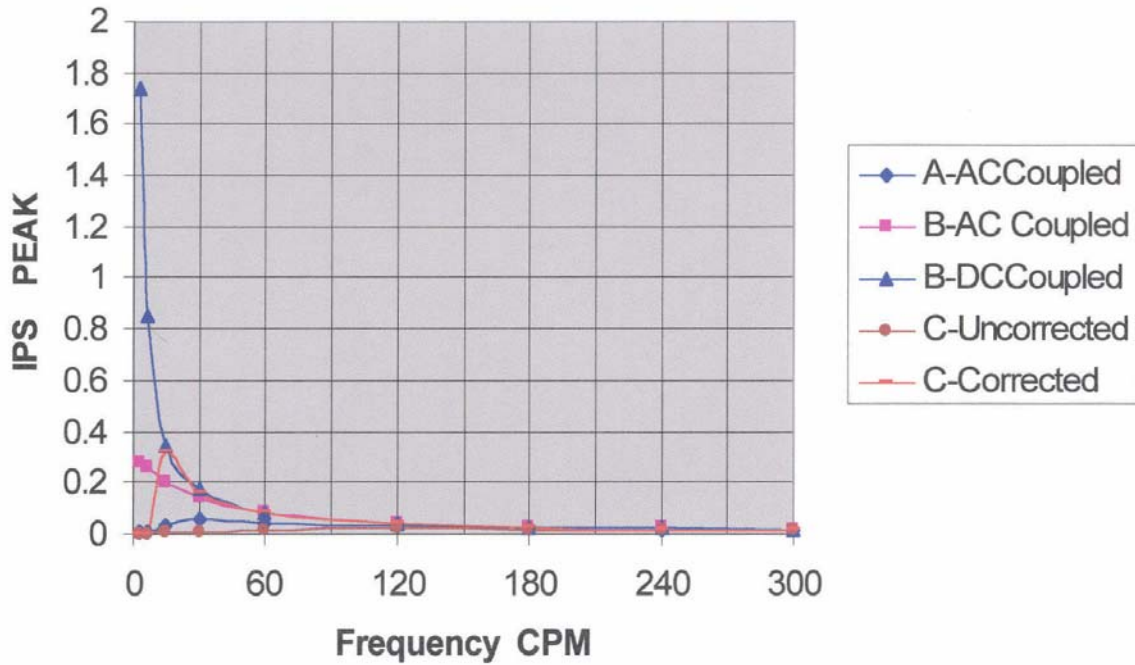
Figure 8. Results, Integrated to Velocity, from Analyzer Brands A, B and C with .001 G RMS Input Signal

CPM	G's RMS Input	Brand A AC Coupled IPS Peak	Brand B AC Coupled IPS Peak	Brand B DC Coupled IPS Peak	Brand C Uncorrected IPS Peak	Brand C Corrected IPS Peak
300	.001	.016	.0171	.0172	.015	.017
240	.001	.019	.0215	.0215	.0173	.021
180	.001	.027	.0285	.0286	.0199	.0279
120	.001	.036	.0424	.0429	.02227	.0416
60	.001	.046	.0814	.087	.01827	.08156
30	.001	.061	.144	.1742	.011	.1631
15	.001	.035	.2015	.342	.00584	.3247
6	.001	.0084	.2601	.8506	.00236	.00236
3	.001	.0073	.2774	1.738	.00119	.00119

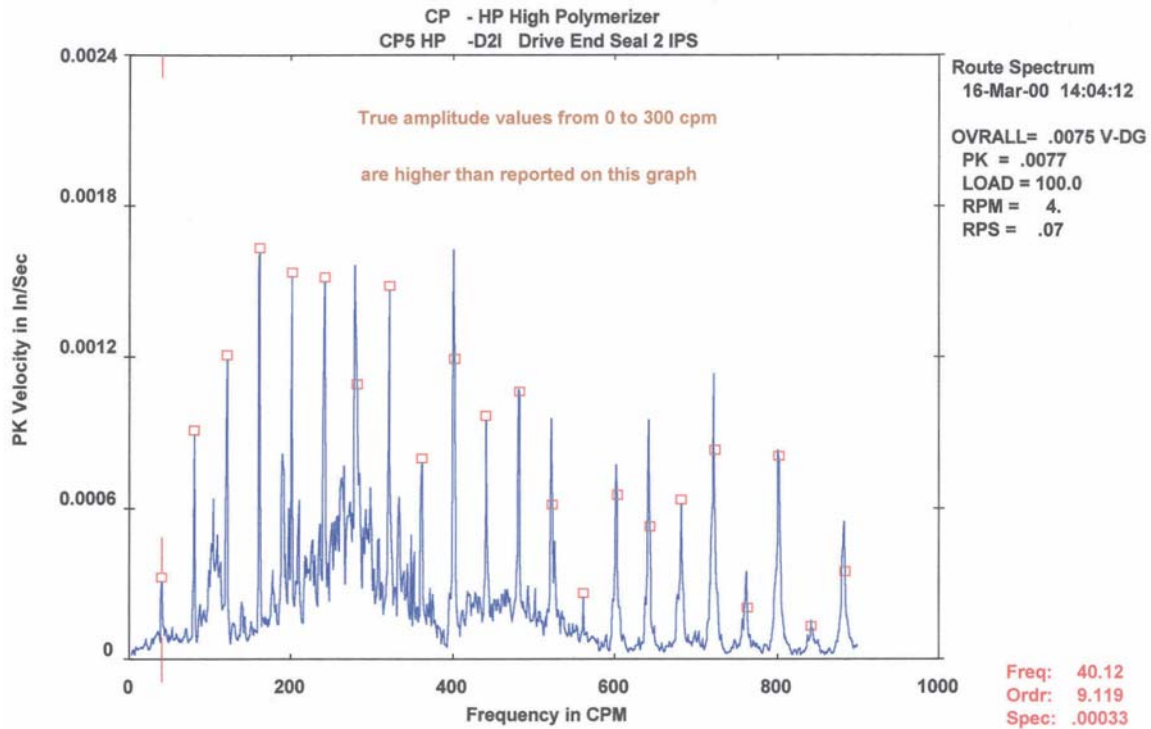
Figure 13. Last Spectrum Taken Before Bearing in Figure 14 was Removed from Service. Shaft Turning Speed of 4.4 RPM

The spectrums in Figures 13, 15 and 17 are for three separate and independent occurrences. Each spectrum was taken with an analyzer in its "uncorrected" mode. For that reason all amplitudes shown from 0 to approximately 300 cpm are in some degree of error. The reason for this is best explained in Figures 8 and 9 where the "uncorrected analyzer" shows poor performance close to 0 cpm. Note that for all values above 300 cpm the amplitudes will be correct.

This particular type of bearing failure generated many harmonics of the 1X BPFO. The amplitude of these harmonics also correlate nicely with the amount of damage found when the bearing was inspected. Also notice with the extensive damage in Figure 18 the spectrum in Figure 17 shows clearly defined turning speed sidebands around harmonics of the BPFO. All cursor values shown in Figures 13, 15 and 17 are of harmonics of the BPFO.

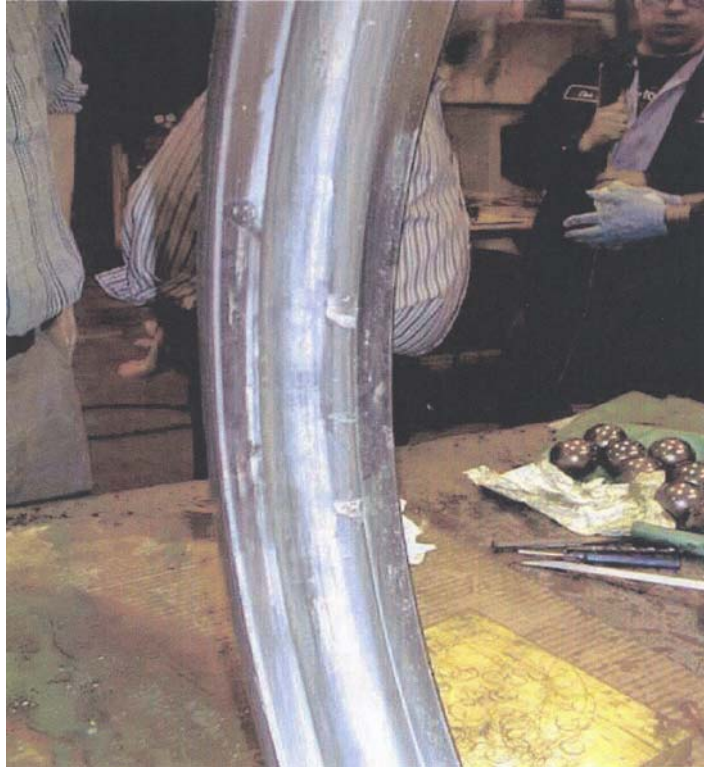
Figure 14. Beginning of Spalling of Bearing Described in Figure 13. Spalling Over 5 Degrees of Arc on Outer Race

After being able to detect bearing damage with conventional vibration techniques we have been able to spot the original onset of spalling. Figure 14 shows the outer race of a bearing from a seal removed in its early stage of spalling. Figure 13 is the spectrum used to make the decision to remove the seal from service. Figure 15 is the last spectrum taken before removal from service. Figure 16 shows a bearing removed with more advanced spalling. Figure 17 showed a significant increase at the 1XBPFO from the previous month and was predicted as the progression from spalling to race cracking. Figure 17 is the last spectrum taken before removing the seal from service. Figure 18 shows the spalling and cracked race of the bearing in the seal analyzed in Figure 17.

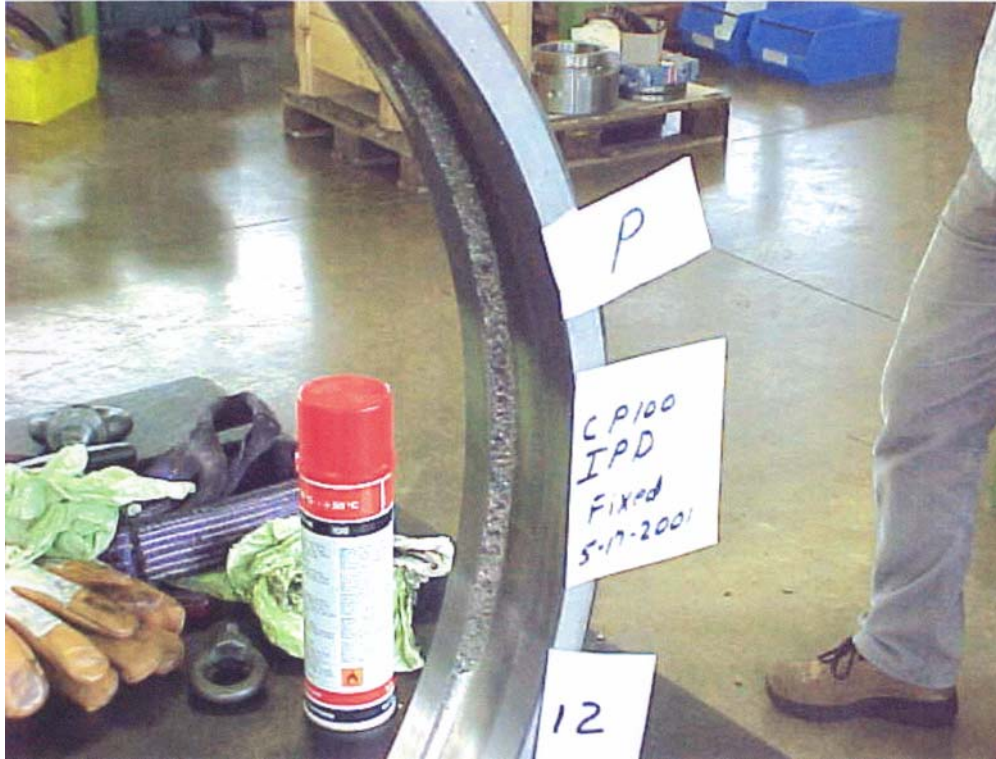
Figure 16. Advanced Spalling of Bearing Described in Figure 15.
Spalling Over 45 Degree Arc of Outer Race

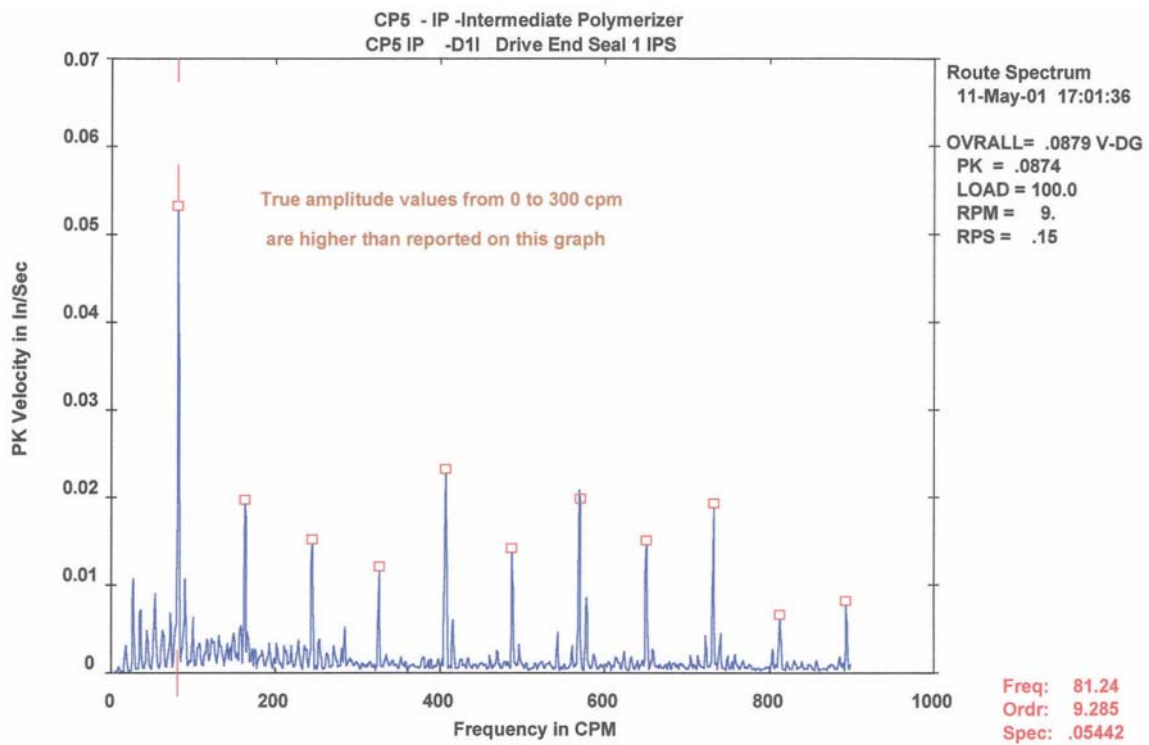
Figure 17. Last Spectrum Taken Before Bearing in Figure 18 was Removed from Service.
Shaft Turning Speed of 8.75 RPM

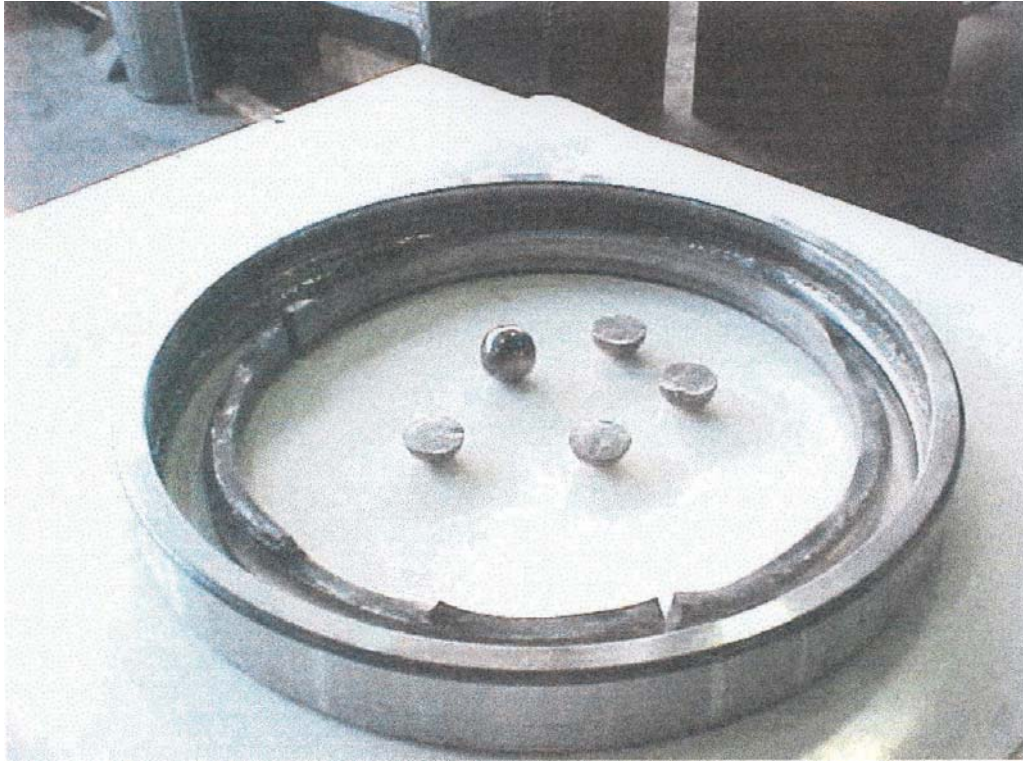
**Figure 18. Bearing Removed from Service Referenced in Figure 16.
Outer Race Spalling Over Full 360 Degree Arc. Outer and Inner Races Cracked.
Two (2) Balls Cracked**

The failure mechanism of bearings in these reactors (due to the slow speed) is different than what I am used to at speeds above 1200 rpm. At the higher speeds I have not usually seen cracked rollers and cracked races. Normally the spalling that starts at high speeds produces frictional heat within the bearing that leads to a temperature related failure of the rollers or races. This shows up in “smearing” of the surfaces or discoloration. Taken to extremes it leads to seizure of the elements to one of the races or the races to the housing or shaft. In the slow speed failure of these reactors (below 12 rpm) although the failure starts as spalling of the outer race there is no significant temperature due to friction of the rolling elements over the spalling. After the race spalling comes race cracking, then roller cracking and foreign damage debris of the races. In the most extreme cases we saw EACH ball cracked in half and the races in hundreds of cracked pieces.
