## **Airborne Ultrasound: Predictive Maintenance for the Masses**

Allan Rienstra, SDT North America

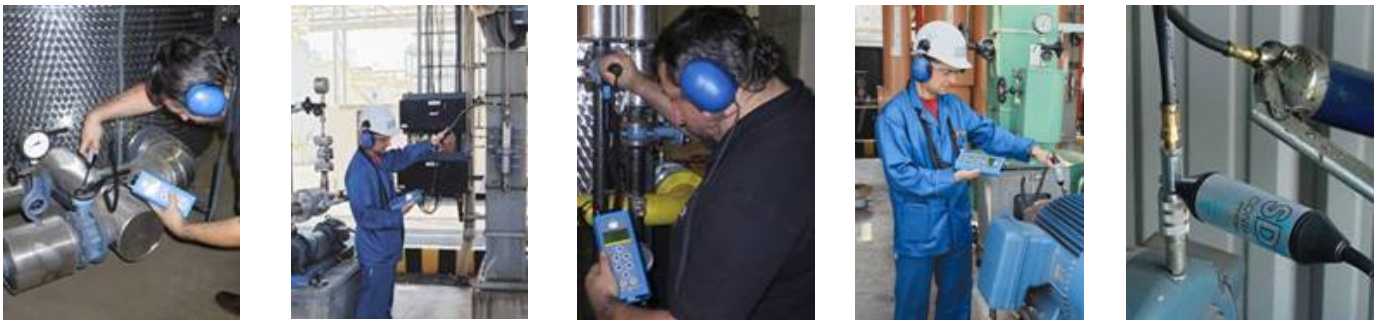
**Figure 1 - Airborne Ultrasound has boundless versatility for virtually any inspection**

**Steam Traps**

**Compressed Air Leaks**

**Condenser Leaks**

**Condition Monitoring**

**Acoustic Lubrication**

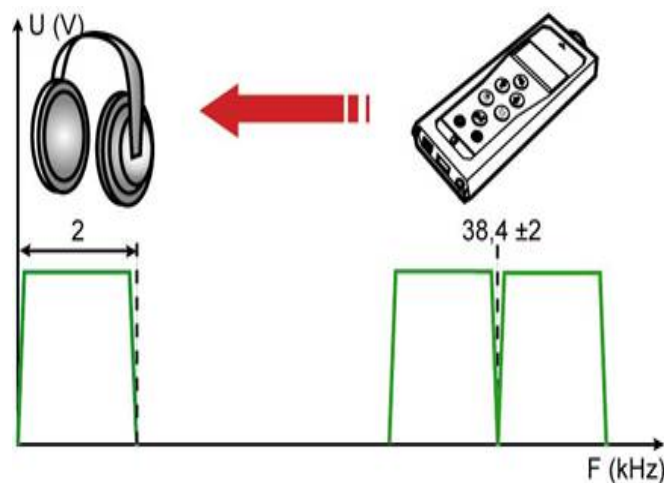
**Figure 2 - Heterodyning effect**

The basic operating principle is to detect high frequency sound pressure waves, beyond the range of our human ears, and transform them to low frequency waves which can be heard through noise attenuating headphones. The sound quality is maintained during this

transformation so what we hear in the sonic range represents the original ultrasonic source. A bearing sounds like a bearing, a leak sound like a leak, and so forth.

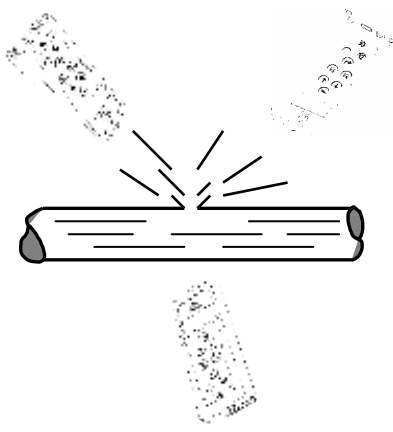
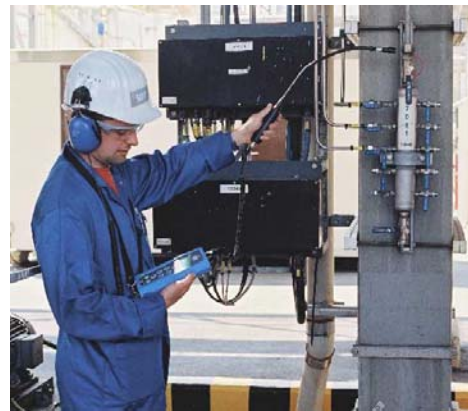
**Figure 3 - Conducting an air leak survey**

Compressed air is a top three high-cost utilities in use at your plant. Leaks are expensive, and often ignored. Most often they can be heard with the naked ear, but are difficult to pinpoint because of background noise. An ultrasonic detector can hear leak turbulence through the ambient noise of the factory floor. The high frequency component of a leak is directional making it easy to locate its source. A compressed air survey with an ultrasonic detector once per quarter can reveal savings potential in the millions and benefit facilities managers looking to improve efficiency and reduce costs.

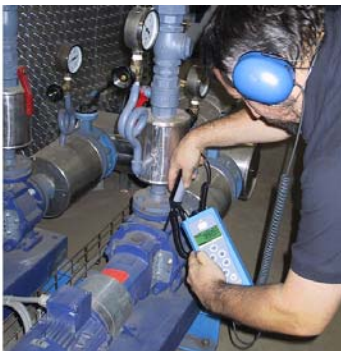
Figure 4 - Monitoring feed water pump

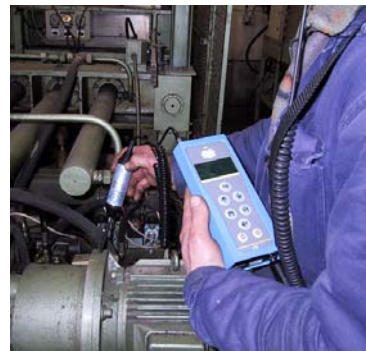
Figure 5 - dB $\mu$ V levels on hydraulic pump motor

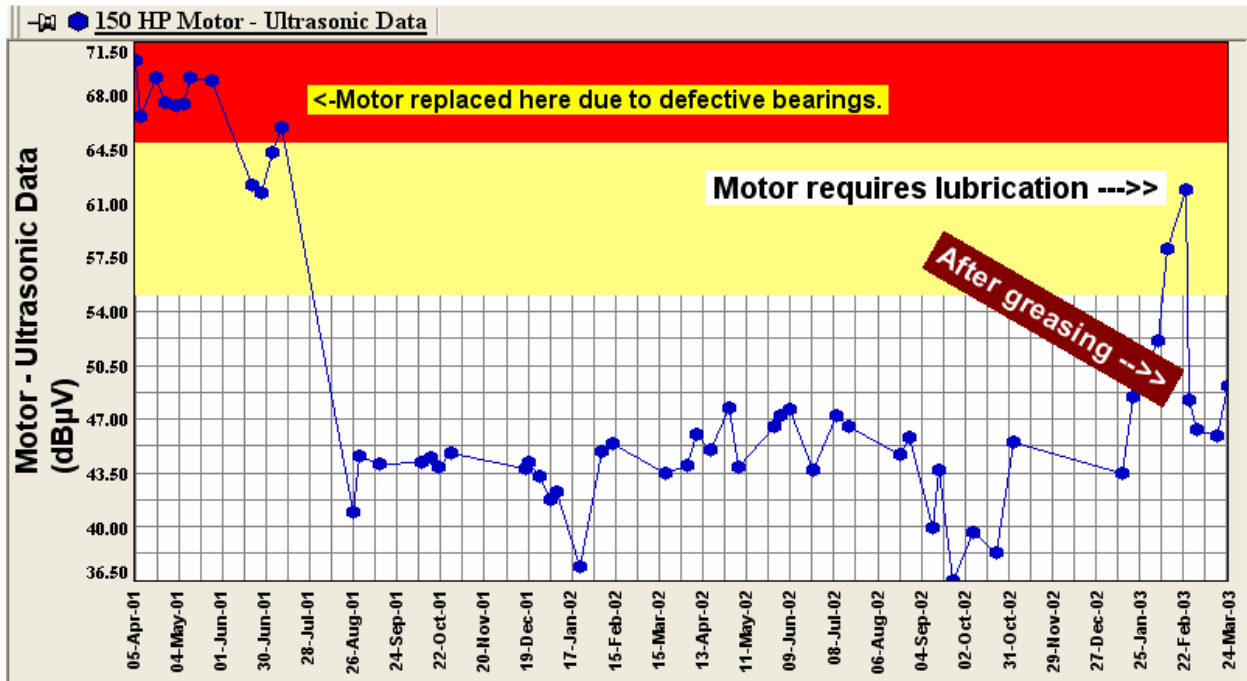
Figure 6 graphs ultrasonic data from the drive-end bearing on a 150HP electric motor used to power a re-circulating pump. Between January 15, 2003 and February 22, 2003, a span of only 5 weeks, ultrasonic values taken with the Ultrawave 170MD raised 12 dB $\mu$ V over normal baseline indicating the bearing needed re-lubrication. Using proper lubrication techniques, the bearings frictional forces returned to a normal level. This was confirmed by retaking dB $\mu$ V readings after greasing. Ultrasonic data collection saved the bearing from running without proper lubrication, and afterwards confirmed that the lubricator applied the correct amount of lubrication; equally important as too much grease would cause the dB $\mu$ V and temperature levels to rise again.

Figure 6 - Ultrasonic dB $\mu$ V readings on 65-028 #2 XLR Re-circulating Pump Motor

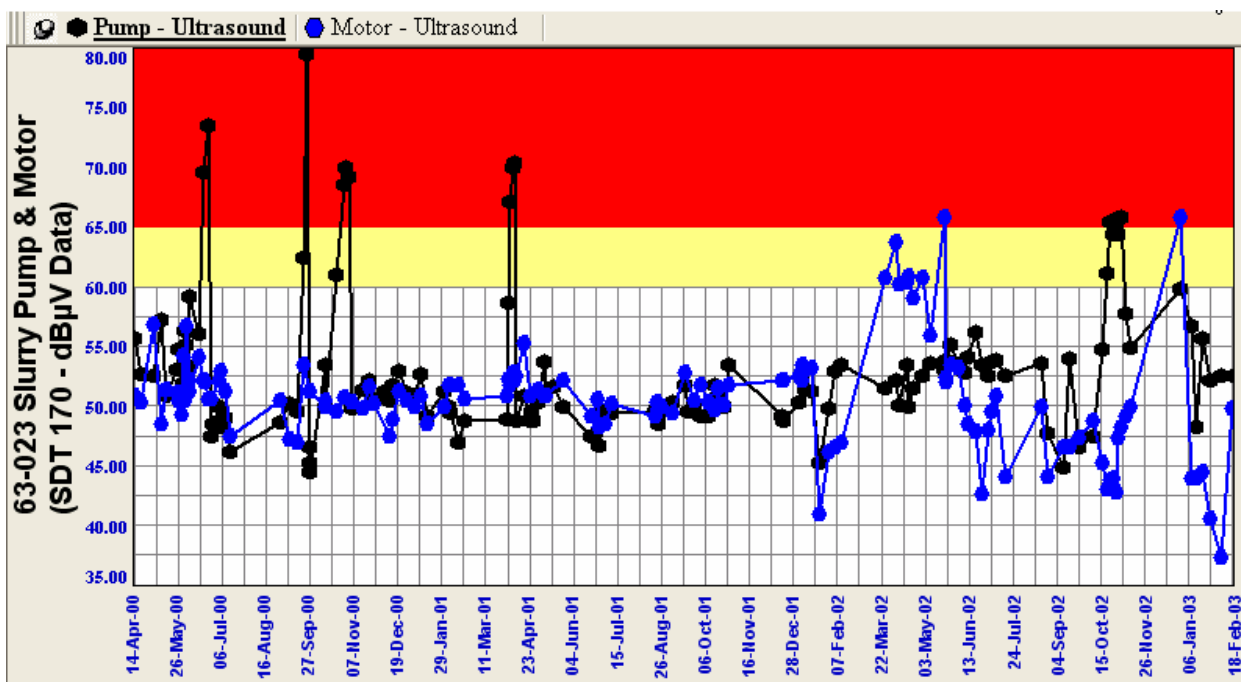
Figure 7 - Ultrasonic dBµV readings on 63-023 XLR Slurry Pump and Drive Motor

Trending ultrasonic readings for this equipment started in April 2000. Every time a dBµV reading enters the red portion of the graph (Alarm Level) the equipment is scheduled for repair as soon as possible. In Potash Corp's case, the ultrasonic alarm level for most of their equipment is set at 65 dBµV. This level was set based on their historical experiences. One failure on this pump occurred at the end of September 2000 when the Ultrawave 170MD detected an 80 dBµV reading, up from 62 dBµV in the early part of September. The pump was replaced with a rebuilt assembly. Only a couple of weeks later the ultrasonic readings entered the alarm level again. Further investigation showed a defective rebuild of the pump assembly. After the pump was rebuilt again and properly this time, ultrasonic readings stayed low for several months.

PCS has established alarm levels for their ultrasonic readings. Figure 7 below is a trending graph of 63-023 XLR Slurry Pump.

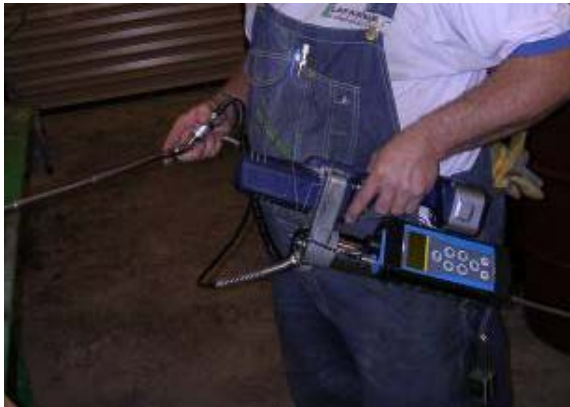
**Figure 8 - Ultrasonic lubrication at Lafarge North America**

There are cases when an inspector is very much in tune with the sound of his bearings and over time, can tell by the quality of sound heard from his ultrasonic data collector that the bearing needs lubrication or is entering an early failure stage. For most cases, the inspector uses the principles of Acoustic Vibration Monitoring (AVM™), which incorporates the science of ultrasound, True RMS signal averaging, and repeatable digital data to determine when the bearing needs lubrication and exactly how much. For decades, time-based lubrication programs were used and within the same time period, bearing failures due to over-lubrication were constant. A new approach to lubrication shifts away from time-based lubrication schedules to a predictive, condition-based schedule utilizing proper ultrasonic trending methods. This technique has become the norm for establishing lubrication requirements on most production machinery.

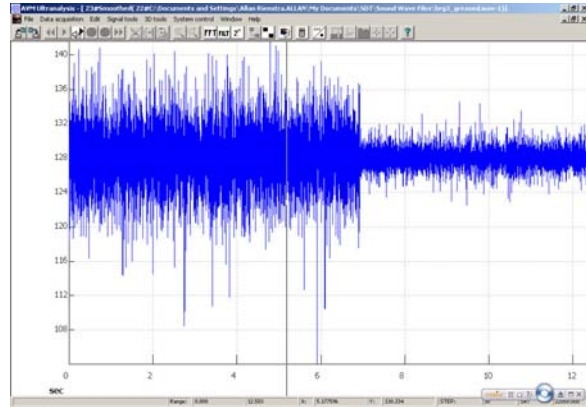
**Figure 9 - Time waveform as bearing is being greased**

Lubricant absorbs friction energy between the rolling elements of a bearing. Acoustic vibration is low when the bearing is properly lubricated but as the lubrication film breaks down this energy increases; even though the bearing may not have any significant wear. An increase of 8 to 10 dB $\mu$ V over historical baseline indicates a need for lubrication. This is confirmed by listening to the bearing's acoustic qualities in the headphones, or by viewing the waveform on a spectrum analyzer. Bearings lacking lubrication will sound louder, with a rough growl, compared to the relatively smooth whirring noises of a well-greased bearing. The time waveform will show inconsistent peaks if the bearing is lacking grease (see Figure 9, before and after lubrication).

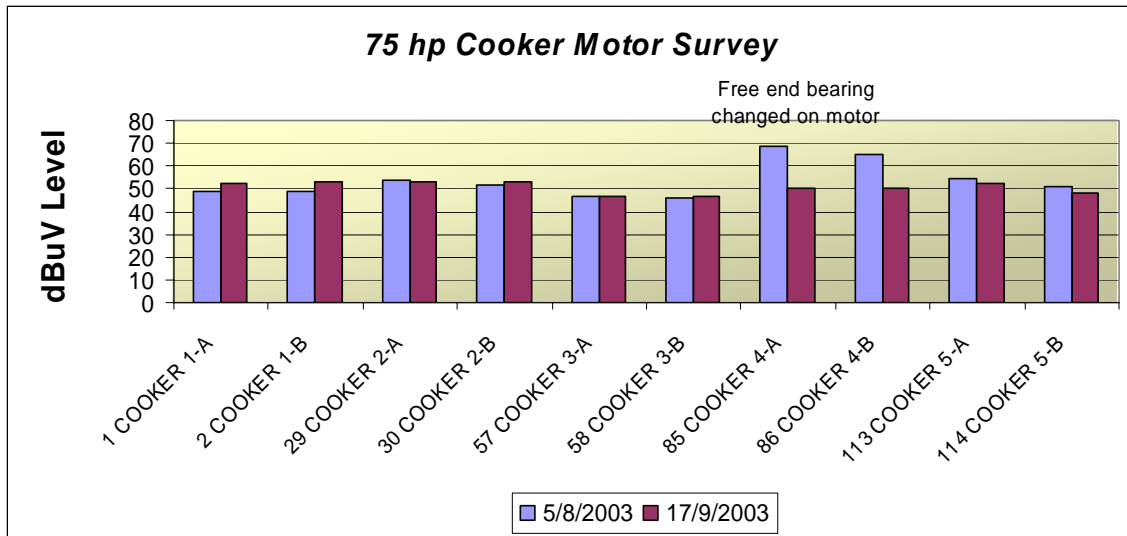
Figure 10 - Ultrasonic readings from 5 cookers at General Mills

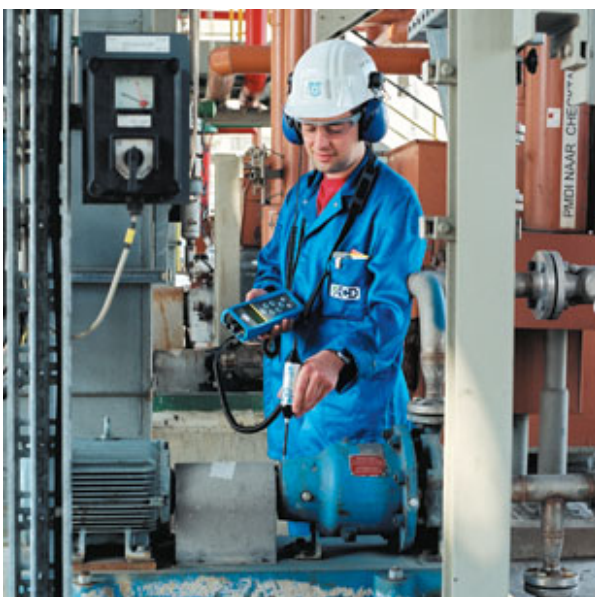
#### Figure 11 - Checking Cavitation

Air pockets form behind the vanes of recirculation pumps causing pitting and deterioration. Place the probe on the vanes first and register the dB $\mu$ V reading. Move the probe to the bearing (as shown at left) and re-confirm the dB $\mu$ V value. Listen to the signal. Is the cavitation sound louder or quieter at the bearing? Does the bearing require grease? After greasing, recheck the pump vanes. Is the cavitation sound still evident?

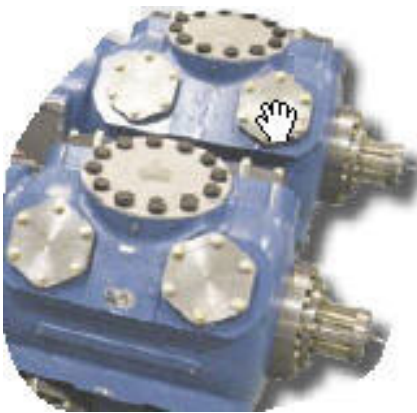
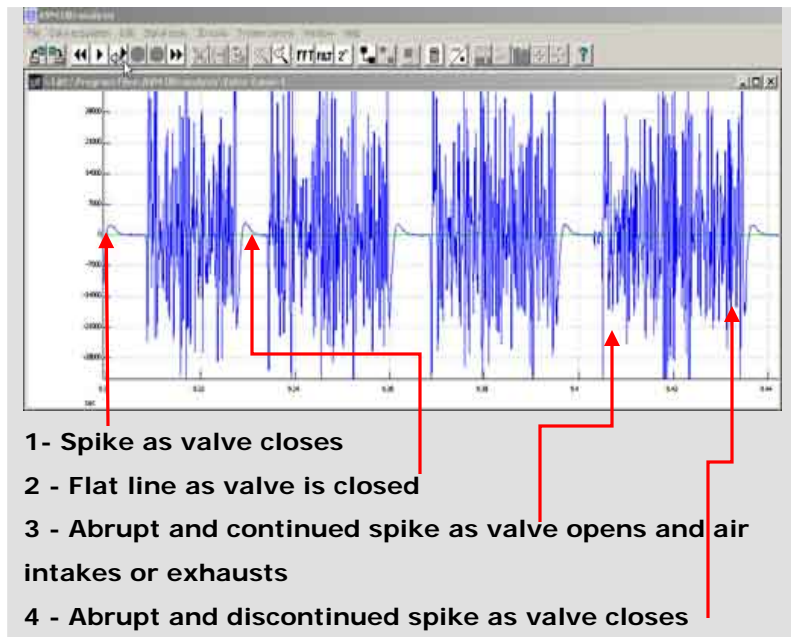
**Figure 12 - Typical Compressor Valve with Time Waveform Shows Open and Close**

By visualizing the recorded sound file of a compressor valve in the time domain a lot can be learned about the condition of the valves and their components. Valves are opened and closed by a spring mechanism allowing reciprocating compressors to intake and exhaust. There are three distinct events (Open, Intake or Exhaust, and Closed) occurring all at split-second timing way to fast for our ears to process. By viewing the wave file in real time we can stretch it out to visualize each individual event. In Figure 12 the waveform shown is four cycles in less than 1/10<sup>th</sup> of a second. It clearly shows the valve closed (2 - flat line at zero), open and intake of air (3), then a small spike as the valve slams shut (1 & 4), and flat lined again to indicate a tightly sealed valve (2). There are a few things to look for in this picture. First, we can trend the small spike as the valve spring pulls closed (1 & 4). As the spring ages and wears this spike becomes smaller and smaller. As a result some noise may appear where the flat line (2) was as the valve

is not held as tightly closed. Weak springs and poorly seated valves will also change the shape of (2&3). As the valves open and close there will be in-leakage or out-leakage lessening the abruptness of the spike. Time wave images are saved and compared over time to see the evolution of wear.

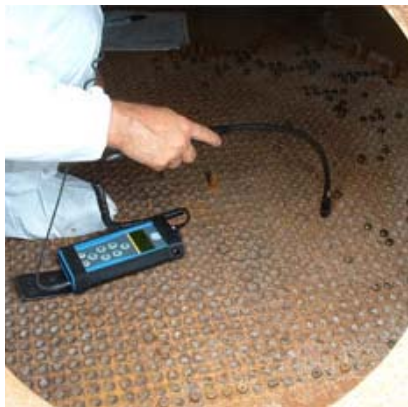
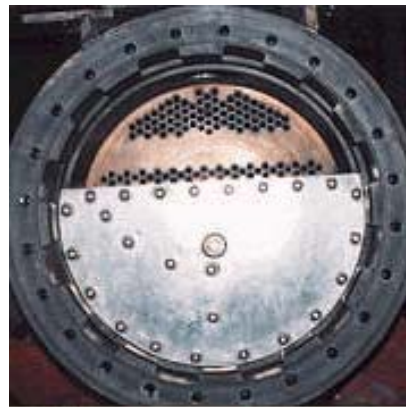
The general method of inspection involves scanning with the instrument a couple feet from the tube sheet. If a noisy area is found it is noted. Switch to an extended flexible sensor and scan tube to tube. If the sound signal on the digital dB $\mu$ V meter or sound in the headset does not change from tube to tube, a leak is unlikely. This is particularly true of tubes located on the outer edges of the tube sheet as these tubes are more likely to have noisy steam flowing over their OD surfaces. If a significant signal change occurs then a leak is suspected. If the leak is within the tube the difference will be heard at the tube opening. If the noise level is heard on the tube sheet, block the area to eliminate reflected noise. Then place a rubber precision tip with an opening of one eighth inch on the flexible extended sensor and hold it almost on the tube sheet surface.

Figure 13 - Inspecting heat exchanger tube sheet and end plate for leaks

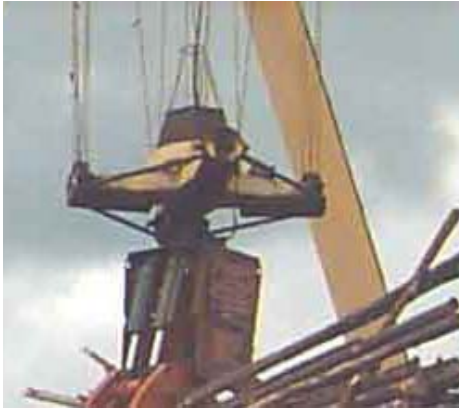
**Figure 14 - Hydraulic Grapple in Timber yard at Koch Cellulose**

Koch Cellulose in Brunswick, GA recently told us how they use ultrasound inspection to find internal leaks on a grapple hydraulic stop valve. The grapple is used to transport tons of timber through the mill yard and any malfunctions pose unwanted downtime.
